Confidential Inspection Report
1025 W. 80th St., Anchorage, AK 99518

February 13, 2015

Inspection Table of Contents

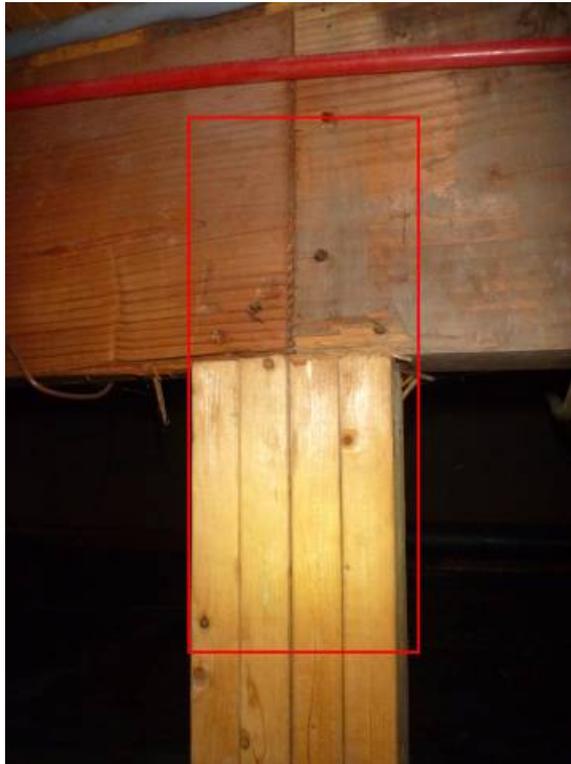
Posts Condition:

The post to beam connection, and post to concrete slab, needs improvement. A metal strap, or metal brackets fastened with "Teeko" or joist hanger nails, are typically used to secure the post to beams in case of seismic movement. Contact a licensed contractor for installation.

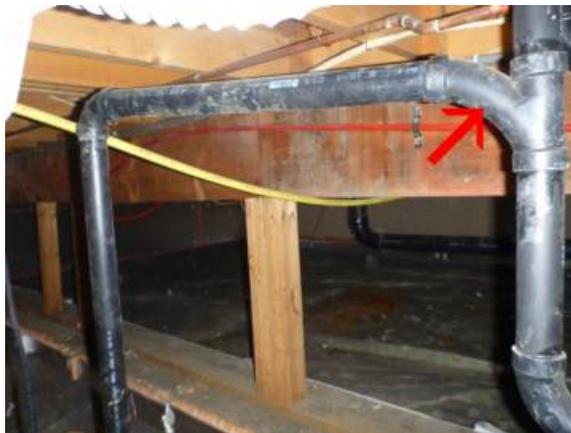
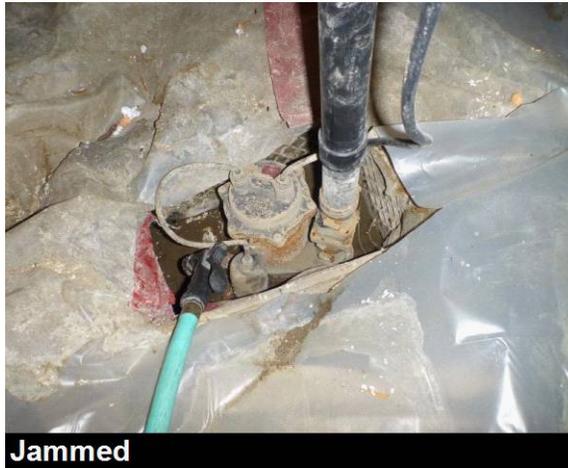
Sump Pump Noted:

3. a) The discharge line enters the sewer which is not allowed by the Municipality of Anchorage. Discharge to the exterior is needed. Contact a licensed handyman for repairs. b) Pump is jammed and does not operate. Replacement is typically needed. Contact a licensed plumber for an evaluation and repairs.

a) The discharge line enters the sewer which is not allowed by the Municipality of Anchorage. Discharge to the exterior is needed. Contact a licensed handyman for repairs. b) Pump is jammed and does not operate. Replacement is typically needed. Contact a licensed plumber for an evaluation and repairs.

Jammed

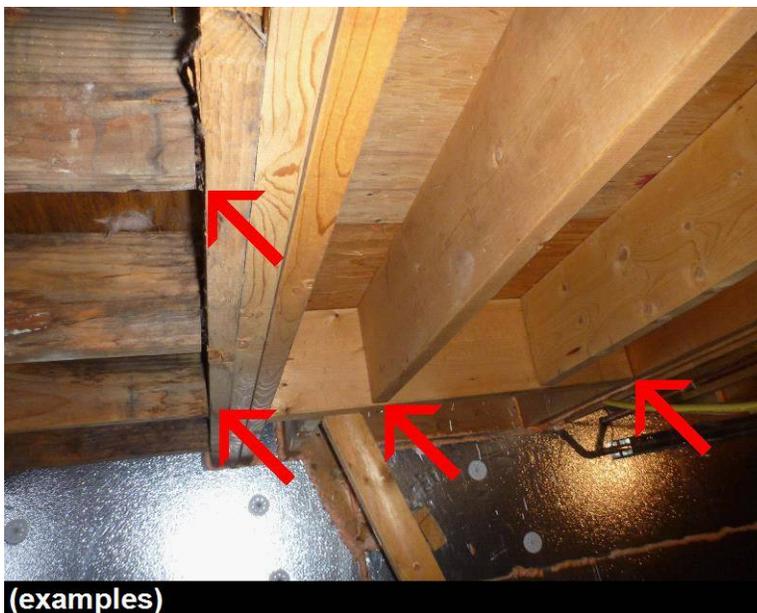
(examples)

4. The floor framing in the crawlspace is missing joist hangers and installation is needed. Contact a licensed contractor for an evaluation and repairs.

- Ceiling Covering Material:** The ceiling covering material is primarily sheetrock.
- Floors:** Carpet. Laminate. The floor framing in the crawlspace is missing joist hangers and installation is needed. Contact a licensed contractor for an evaluation and repairs.

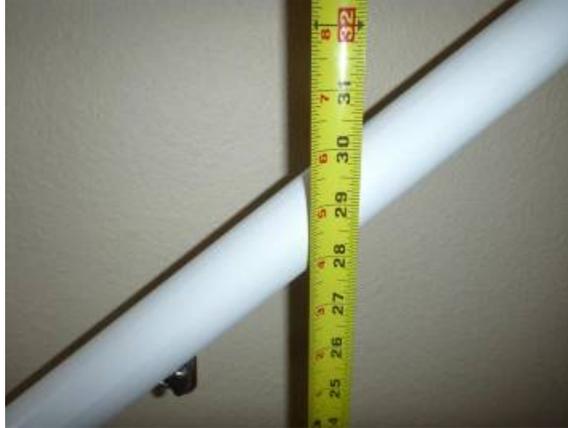
1. The handrail(s) are installed under the minimum height of 34" (maximum 38") from the nose of the tread. Repairs are needed.

Interior Stairs: The handrail(s) are installed under the minimum height of 34" (maximum 38") from the

nose of the tread. Repairs are needed.

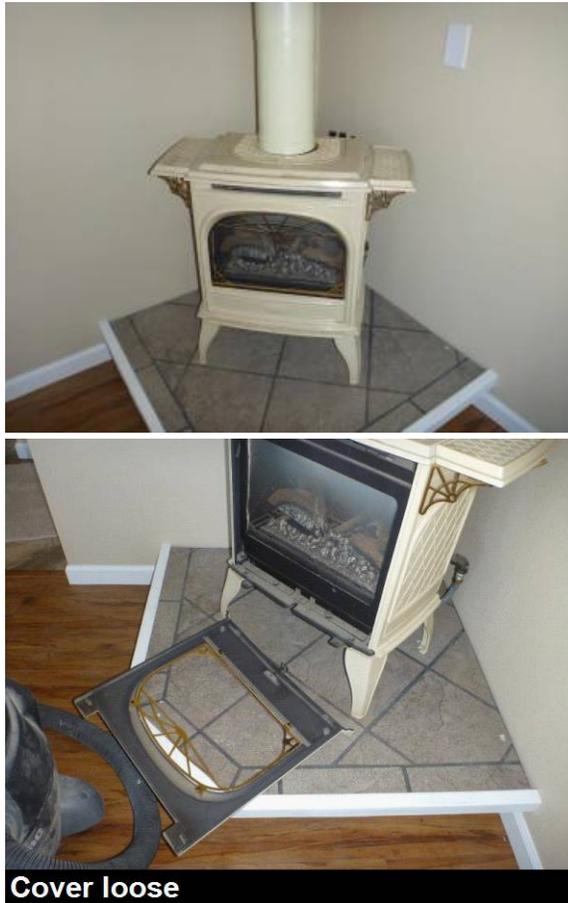
The exterior cover is loose and minor repairs are needed.

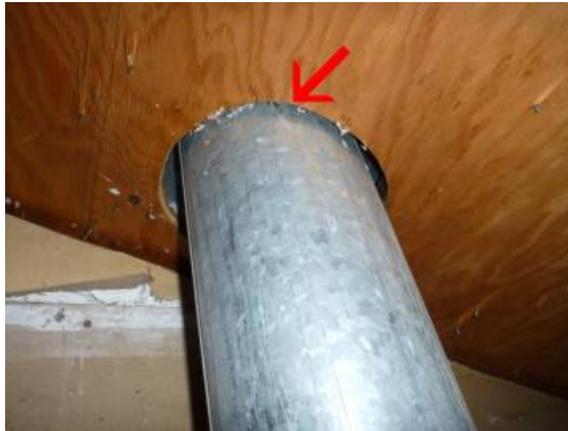
5. The exhaust double walled ("B") vent does not appear to have proper clearance to combustibles (1") in the attic. Contact a licensed heating contractor for repairs.

Flues, Vents, Plenum: The flue pipe is metal. The exhaust double walled ("B") vent does not appear to have proper clearance to combustibles (1"). Contact a licensed heating contractor for repairs.

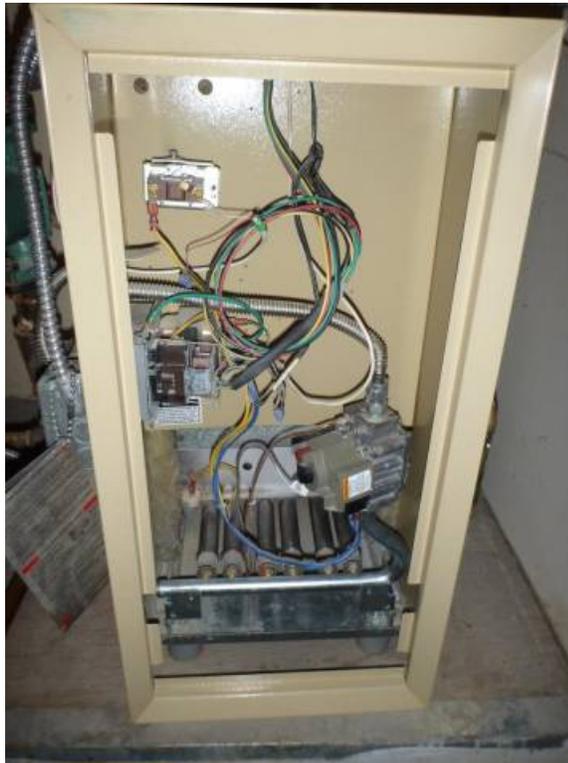
1. It does not appear the boiler has been serviced in the last 12 months. If proof is not available, it is recommended to have a licensed contractor inspect, service and make any needed repairs prior to close.

Unit was operational at the time of inspection. General condition appears serviceable. Burner Flame(s) appear typical. It does not appear the boiler has been serviced in the last 12 months. If proof is not available, it is recommended to have a licensed contractor inspect, service and make any needed repairs prior to close. Technical inspection and exhaustive system operation check is not within the scope of this inspection.

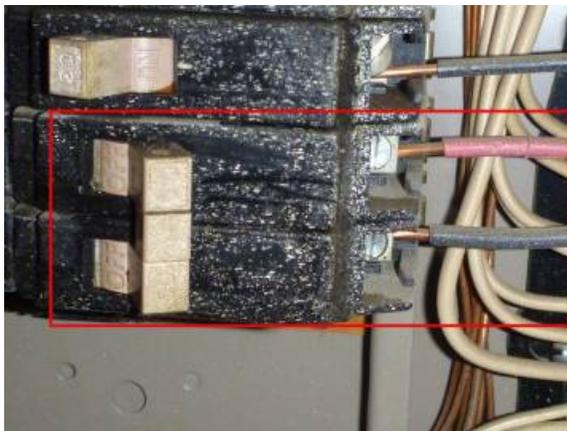
2. The dryer breaker in the main power panel is inappropriately matched with wire gauges that are too light for the breakers allowed draw. An overdraw condition could cause melting, insulation overheating, or fire. 50 amp dryer circuit has 30 amp wiring. Contact a licensed electrician for an evaluation and repairs.

The dryer breaker in the main power panel is inappropriately matched with wire gauges that are too light for the breakers allowed draw. An overload condition could cause melting, insulation overheating, or fire. 50 amp dryer circuit has 30 amp wiring. Contact a licensed electrician for an evaluation and repairs.

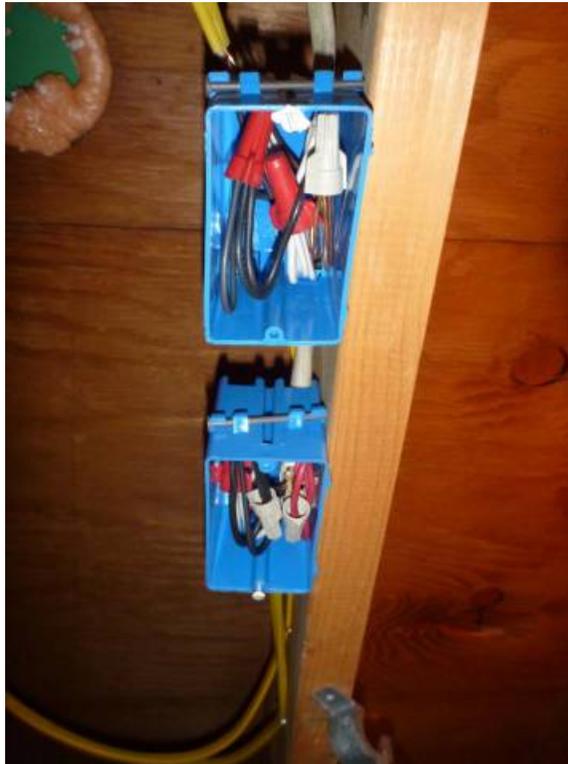
3. Open junction boxes in the crawlspace need cover plates installed. Contact a licensed electrician for minor repairs.

Open junction boxes in the crawlspace need cover plates installed. Contact a licensed electrician for minor repairs.

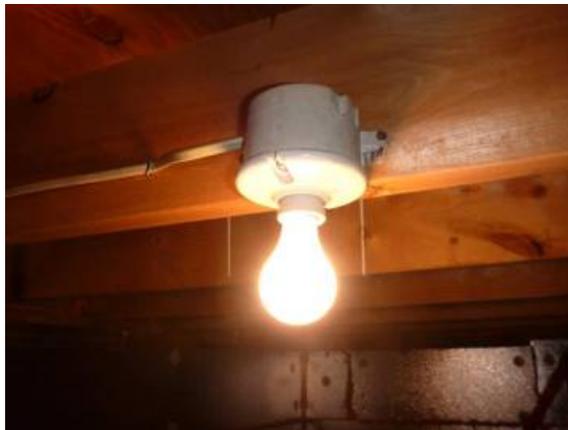
4. Metal bulb protectors (baskets) are needed at all incandescent light fixtures with exposed bulbs. Crawlspace fixtures need protection. Contact a licensed electrician for minor repairs.

Metal bulb protectors (baskets) are needed at all incandescent light fixtures with exposed bulbs. Crawlspace fixtures need protection. Contact a licensed electrician for minor repairs.

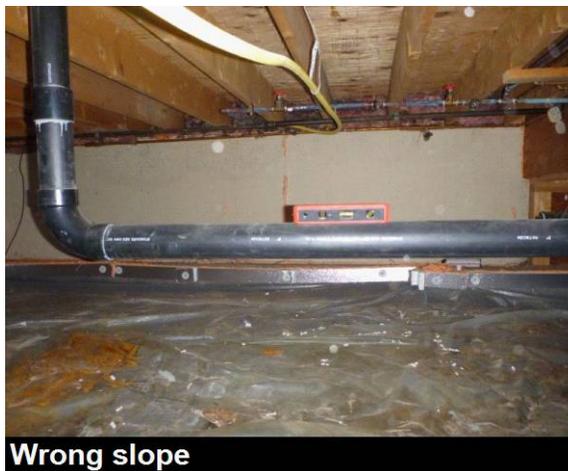
6. The slope of the drainage system is not adequate for the solids to flow in the line. A slope of 1/4" to 1/2" per foot is needed. Repairs would need to be made by a licensed professional plumber.

- Waste Piping Condition:** The slope of the drainage system is not adequate for the solids to flow in the line. A slope of 1/4" to 1/2" per foot is needed. Repairs would need to be made by a licensed professional plumber.

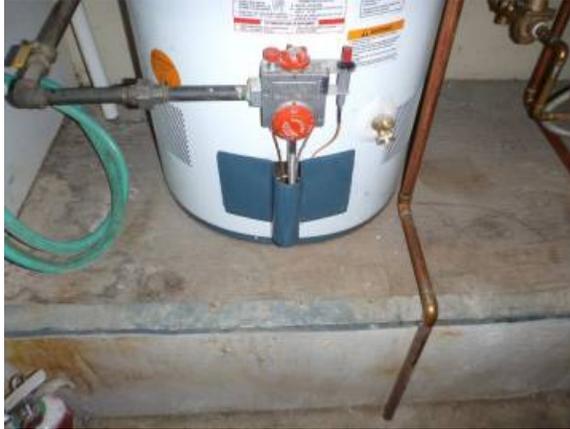
Location: Garage. The Municipality now requires a galvanized pan or a waterproof cover installed on the water heater platform to prevent damage if the water heater should leak.
Note: An exception applies should the garage floor slope to the exterior. Contact a licensed plumber for recommendations and possible upgrades.

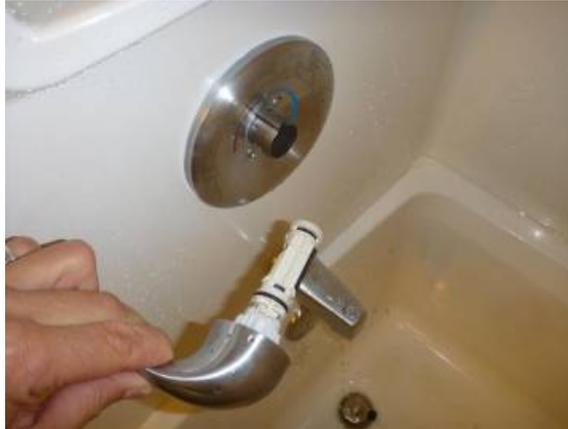
Upstairs Bathroom:

7. The mixing valve was installed incorrectly and discharged into the tub after 10 seconds of usage. Water was then turned off by inspector. Contact a licensed plumber for an evaluation and repairs.

The mixing valve was installed incorrectly and discharged into the tub after 10 seconds of usage. Water was then turned off by inspector. Contact a licensed plumber for an evaluation and repairs.
