Confidential Inspection Report
1025 W. 80th St., Anchorage, AK 99518

February 13, 2015

Inspection Table of Contents

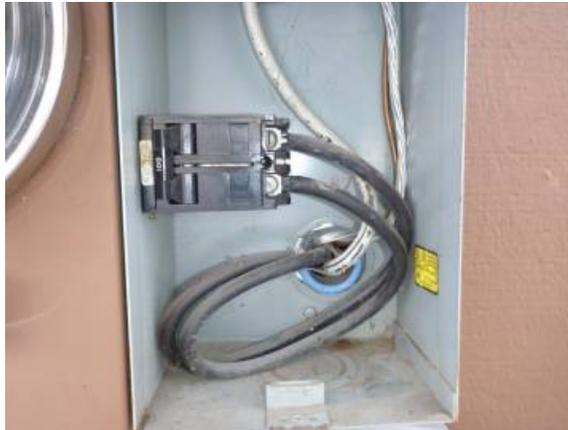
Electric Service: Underground.

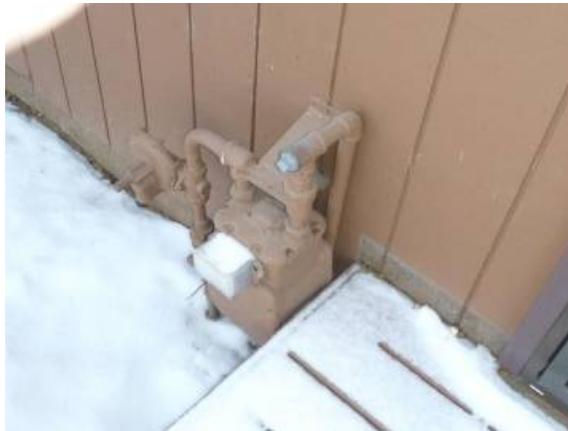
Location of Meter: Rear side of the house.

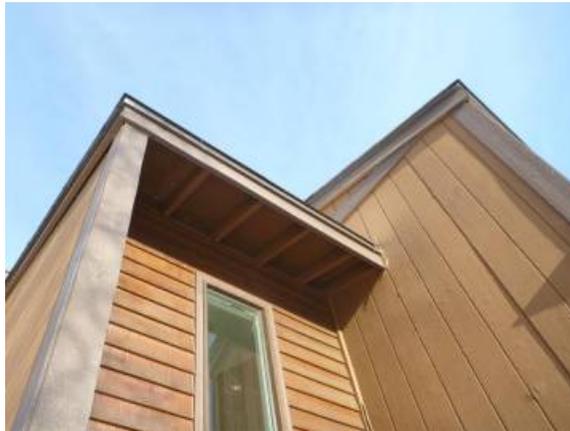
Type Roof:	Gable.
Roof Covering Materials:	Asphalt composition shingles. These consist of cellulose mat, asphalt impregnated with colored gravel on surface. Shingles are applied in horizontal rows. Winter conditions prevented a thorough inspection of this item. Contact the seller for a disclosure concerning the roof covering. You may consider contacting a licensed roofing contractor for an inspection of the roofing prior to close. This typically means the roof would have to be clear of snow and ice however.
Slope:	Medium slope: considered to be between 4 in 12 and 6 in 12.
Gutters:	Partial. It is recommended to install additional gutters to direct roof runoff away from the structure.

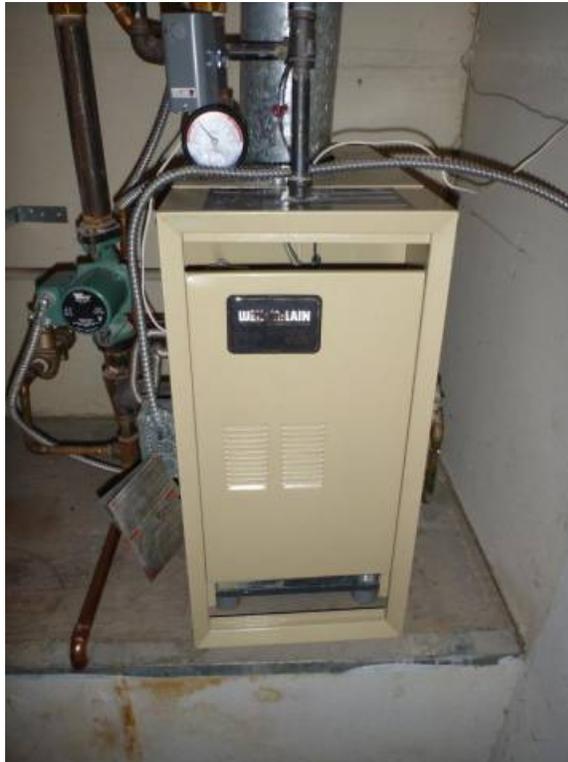
Heating System Type: Boiler.
Heating System Location: Garage.
Fuel Source: Natural gas.
Equipment Description: System is Weil McLain. Mid efficiency.

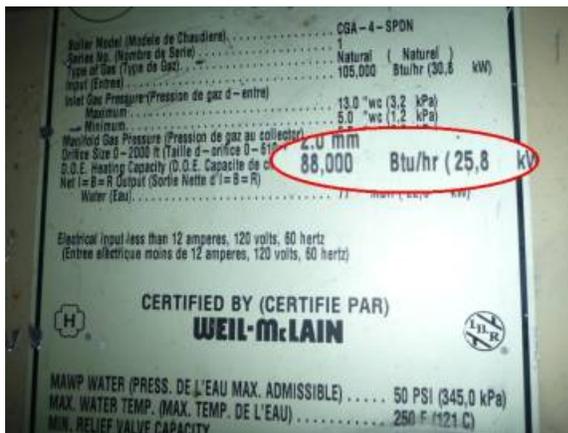
Capacity: 88,000 BTU.

Flues, Vents, Plenum: The flue pipe is metal. The exhaust double walled ("B") vent does not appear to have proper clearance to combustibles (1"). Contact a licensed heating contractor for repairs.

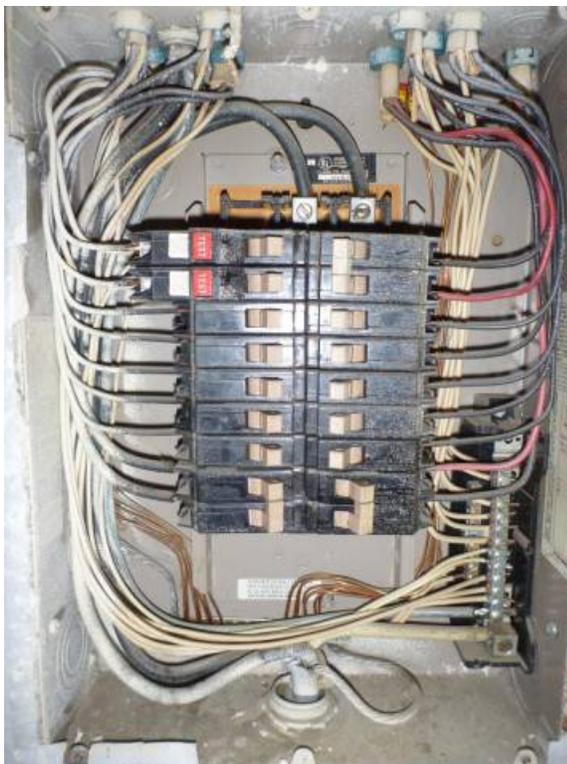
- Main Panel Location:** Garage.
- Panel Accessibility:** Yes - The electrical panel is in a location that makes it readily accessible.
- Panel Cover Removed:** Yes.

- Main Circuit Rating:** 100 amp - The ampacity of the main power panel appears to be within the normal parameters for the structure's age. However, a load analysis is recommended if you

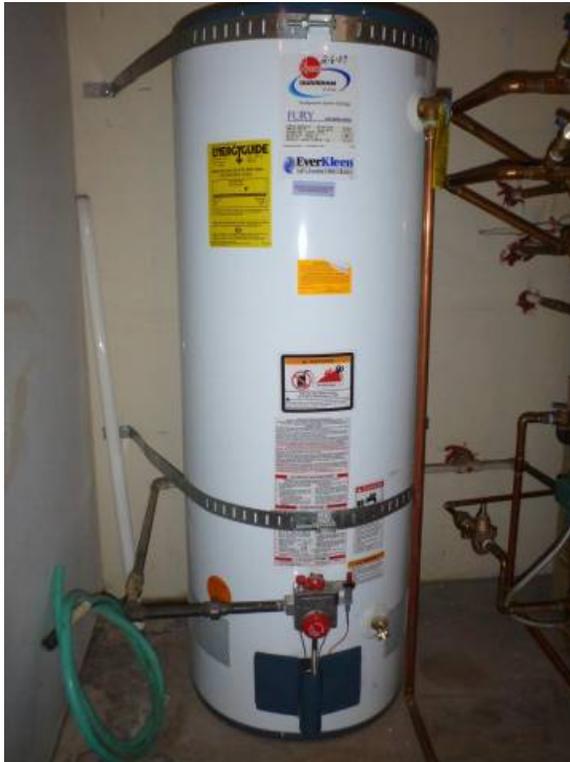
System is Rheem brand. 2006 model.

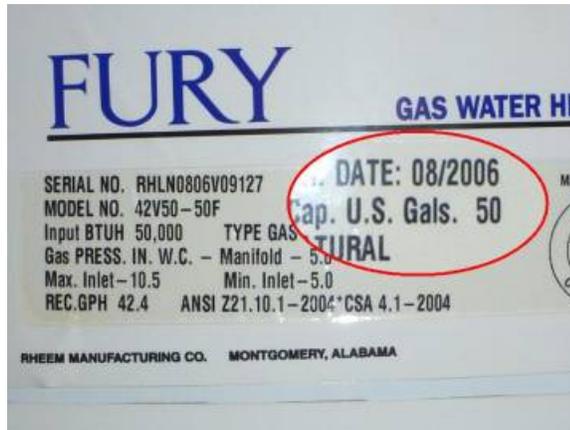
A 50 gallon water heater is installed.

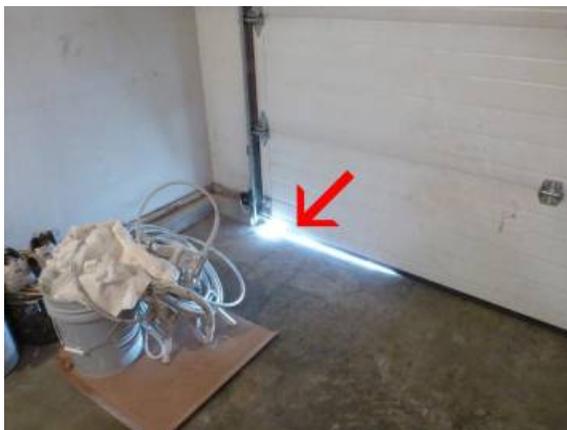
Garage Type The garage is attached.
Size of Garage: One car garage.
Number of Overhead Doors There is a single overhead door.
Overhead Door and Hardware Condition: Satisfactory - The overhead door is in satisfactory condition, and it is functional. Weatherization improvements are recommended for the garage door due to poor air sealing. Contact a licensed garage door professional for recommendations.

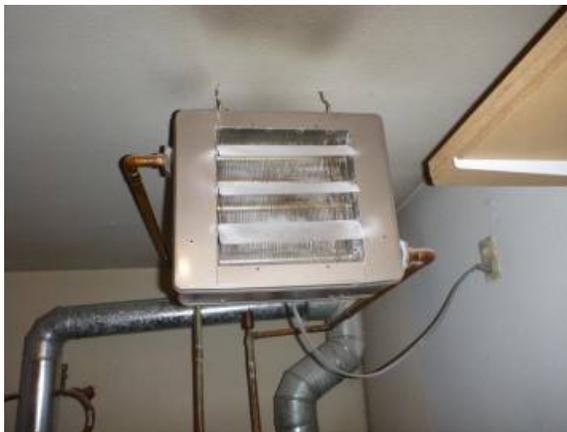
Appears serviceable.
